BUNCEFIELD AND BEYOND

Important lessons for developing countries

Abhay D. Purandare
B.E., MIFireE (UK)

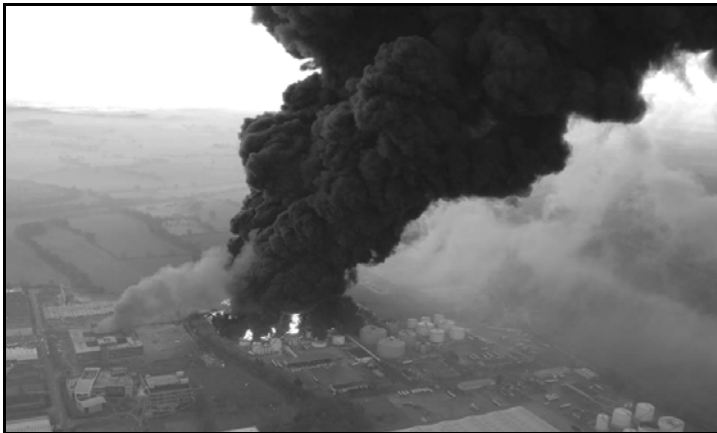
Fig 1. The smoke from the fire was seen from satellite images

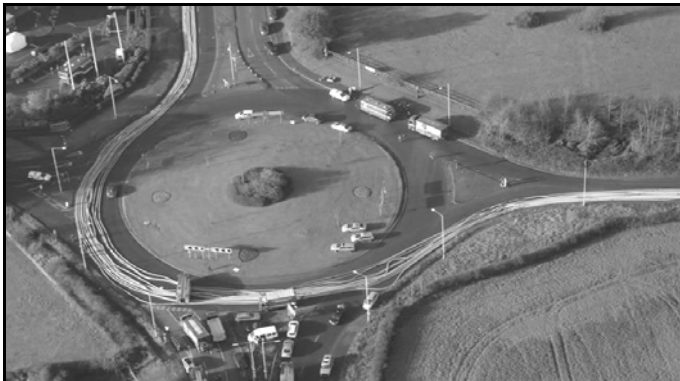
As the onsite fire water network was damaged in the initial explosions, water had to be transported from the nearest water source, which was a pond 1.8 kms. away. Six high volume pumps were set up at the pond, with six more pumps deployed at various locations to serve as boosters. A hose relay system using high volume hose and booster pumps allowed the movement of required amount of water at adequate pressure to site. Approximately 32,000 liters of water was being used per minute, and a total of 30 kms of hose length had to be laid out for transporting this to site.

Fig. 2. A long hose relay system was used to supply water to the incident site

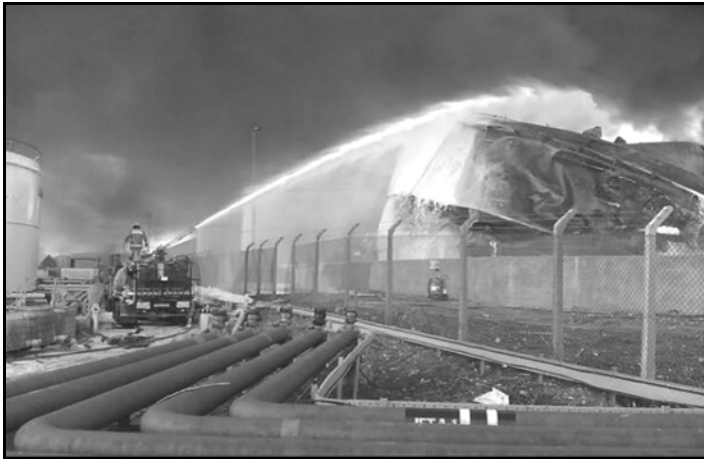
As mentioned earlier, the application of foam was over the top using trailer and vehicle mounted monitors. Foam monitors used were of both types i.e. those discharging aspirated (primary aspirated) and non-aspirated (secondary aspirated) foam. FP foam compound was used with both types of monitors and seemed to work effectively with both.

Fig. 3. Mobile and Vehicle monitors were used for the foam attack.

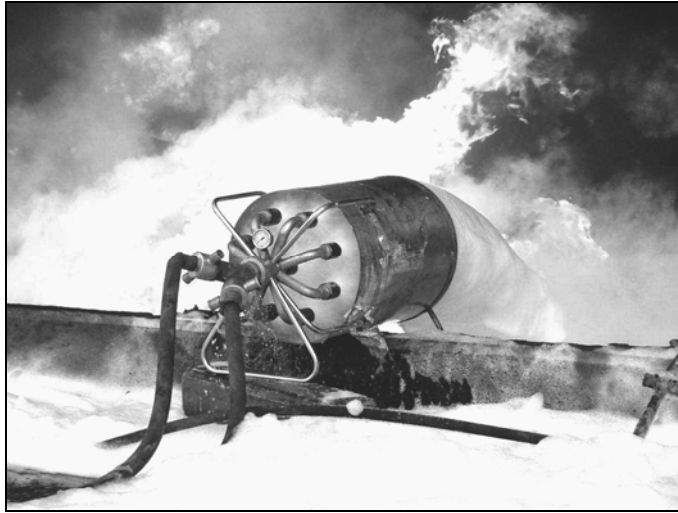
Overpressures resulting from vapour cloud explosions are strong enough to cause extensive damage to equipment and structures on industrial sites. The Buncefield incident was no different as there was tremendous damage both within and outside the terminal due to the blast waves of the initial explosions. Such blast waves cause the movement, and in some cases, cracking of pipelines and its joints. This, in turn, leads to leakage of liquids in large quantities, posing the risk of dike fires. Also the leakage of Petrol in the initial stages had led to the liquid spreading throughout the bund, and subsequently, catching fire. Therefore, one of the major factors of the operations, was putting out the fires in the bund area, as they not only complicate the situation, but have the potential to further escalate the incident. For this, the firefighting teams used Medium expansion (MX) foam, as due to its larger volume, it can cover the liquid much faster than low expansion foam. This was achieved using Medium expansion Bund Pourers, and once again the foam compound used was FP. It worked very well for this application, as being protein based, it is more sticky and could hold the foam onto the pipework, valves, etc, resisting the effects of wind and heat longer. This resulted in

quick extinction and later, preventing the reignition of spilled fuel. This prevented the escalation and complication of the incident.

Fig. 4. MX Foam Pourers in action at the Buncefield incident.
