TAKSHASHILA ARCADE FIRE AT SURAT: A TECHNICAL ANALYSIS

By Abbay Purandare

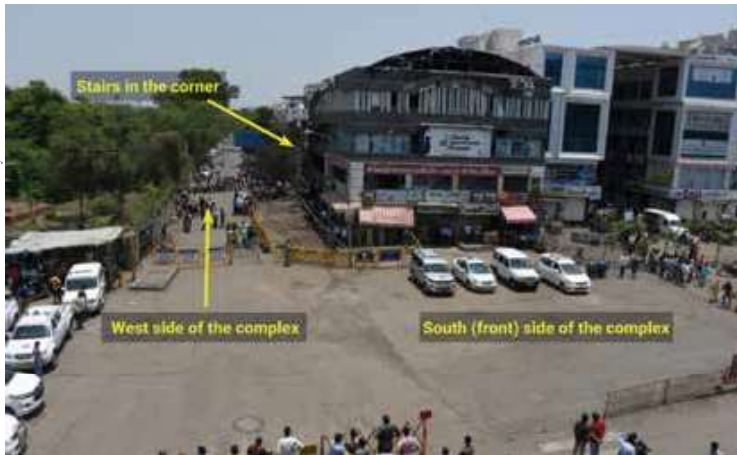
Fig 1. Building complex layout and access

Road on south side of the complex is the main Sarthana Jakat Naka-Kamrej road, along with the Sarthana flyway (which gives a clear width of over 12.0 metres on this side). Road on the west side is a 6.0 metre wide road with the Sarthana nature park and zoo on the other side of the road. There is another commercial complex adjacent to it on the east side (with a gap of more than 6.0 metres) while the building abuts a 2 storey villa on the north side. From a fire brigade access point of view, the south and west side of the complex are easily accessible.

There is sufficiently wide fire brigade access from two sides of the building to carry out external firefighting and rescue operations (See Fig. 1). Access for internal rescue is from the only stairs on the north-west side. As most of the readers are aware, municipal hydrant systems are non-existent in almost all major Indian cities. This puts a strain on the water supply requirement at a fire incident scene, and the large numbers of fire vehicles at a scene (and reported in media) are required to cater for this arrangement. Where larger vehicles such as turntable ladders, or hydraulic platforms could be mobilized, the access path should have the load-bearing capacity of these heavy vehicles (which is specified in the building codes/ rules); this was not an issue in this incident.

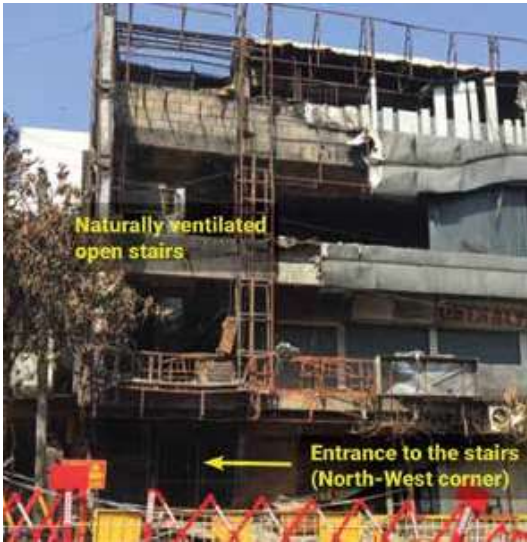
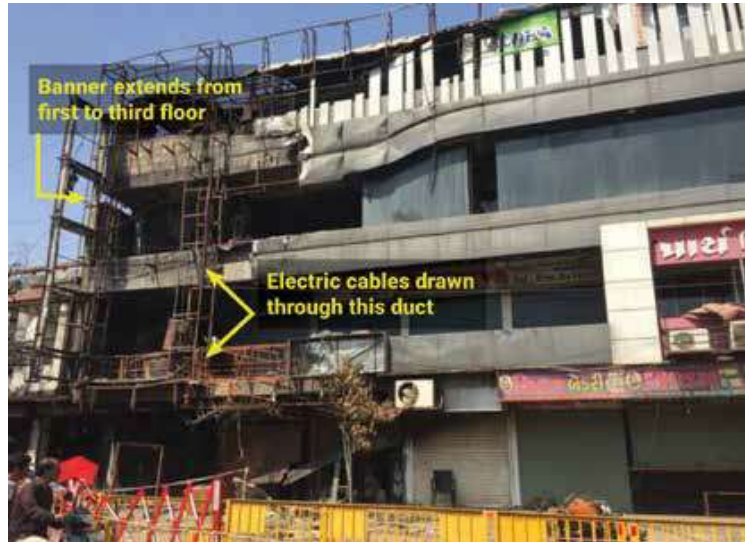
Fig 2. Egress arrangements of the building

As stated earlier, there is a single stair located on the north-west corner of the building which exits directly on the road (on west side). This stair, approximately 1.2 metre wide, extends from the ground to the third floor and is of concrete construction with metal railing. It appears (as is also mentioned in media reports) that the access to the fourth floor was added later on, and based on eyewitness reports, this was fabricated out of steel frame with wooden parts (the author assumes that either the treads or the landings or both were made of wood construction). An external metal stairs is present on the south-east corner (front side) of the building; however, this provides access only to the first floor.

The stairs are naturally ventilated (open from one side) and it is assumed that this must have some kind of opening at the original terrace level. This design would logically not allow accumulation of smoke; however, this is what happened in the incident. There are electric meters located below the staircase at ground floor, and cables for upper floors passed through a duct above the stair entrance (where it is believed the fire originated). On one side of the stairs (North-west corner) an illuminated banner (steel frame covered with plastic fabric or sheet) was fixed; this extended from

the first to the third floor. On the other side of the stair is the enclosed duct carrying electrical cables (Refer Fig. 2).

- Older buildings (which are non-compliant from egress design point of view) need to be checked for design of stairs, fire hazards which could affect its safety (hoarding, materials, electrical equipment located in or near stairs).
- Modifications/ changes to building design need to be carefully evaluated from a fire risk perspective. Concerned (Municipal/ Fire) officials need to be trained and certified to carry out fire and life safety assessments for building designs. Implementation of building rules/ codes should be in spirit and not just for compliance. Concerned officials need to be trained and certified to carry out fire and life safety assessments

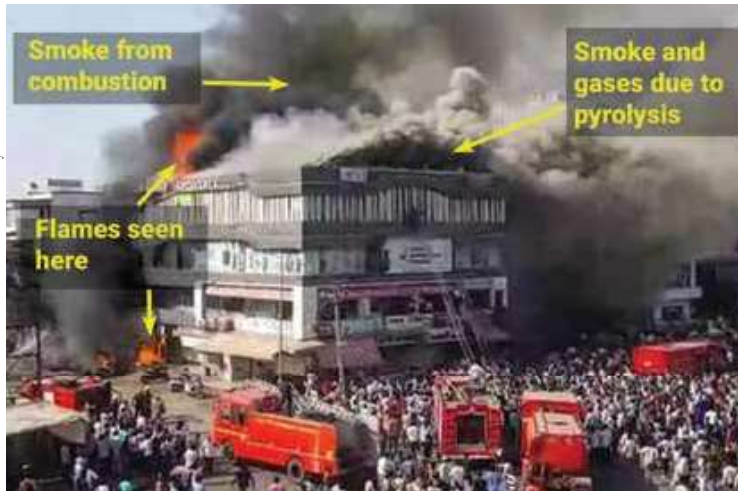
Fig 3. Fire incident in progress,

It is evident from the condition of the building after the incident that the heat damage to the ground, first and second floors is minimal. Except the shutters of the two shops on the ground floor adjacent to the stairs (which are heavily damaged), other shops on the first floor and institutes on the second and third floor show minimal evidence of damage from the fire, except for some damage to the external ACP material fitted there. It is therefore, clear that smoke and heat from the original fire did not penetrate into the first and second floors. There is some damage on the third floor near the stairs, but again this is limited to around 5 metres from the stairs. It appears that material was stored near the stairs on the fourth floor and hot smoke travelling up the stairs finally ignited the pyrolysing material kept here, and flames were seen on the fourth floor, but not

on the second and third floors (See Fig. 3). Construction on the terrace appears to be non-RCC, using synthetic materials, which may have contributed to the fire.
